Manhole Inspection Summary

Manhole # S29E__006MH

Insp Date: **9/25/08 10:26 AM**

Location Address: **663 Vine St**

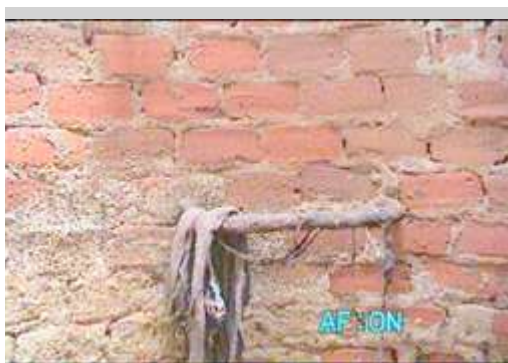
Defect 5

☒ **Evidence Of Surcharge**

Depth: **1**

evidence of surcharge

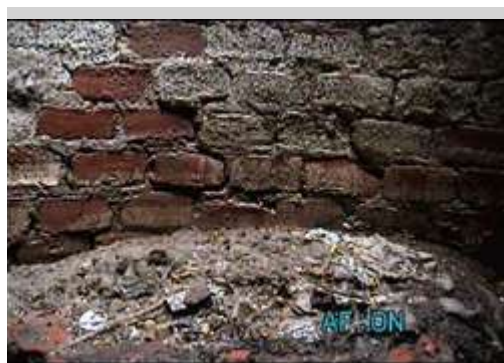
Defect 7

Condition: ☐ Sound ☐ Cracked ☐ Root Intrusion ☐ Loose Brick ☒ **Deteriorated**

Infiltration: ☐ None ☐ Joint ☐ Cracks ☐ Mortar ☐ Roots ☒ **Wall**

deteriorated barrel

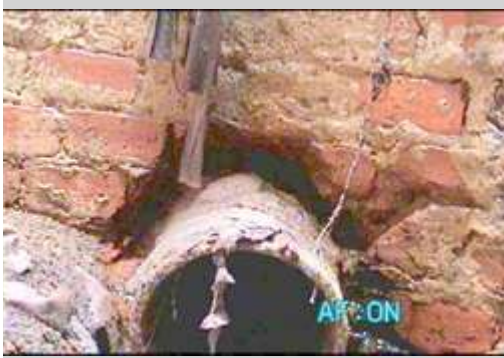
Defect 6

infiltration side of pipe, corroded pipe

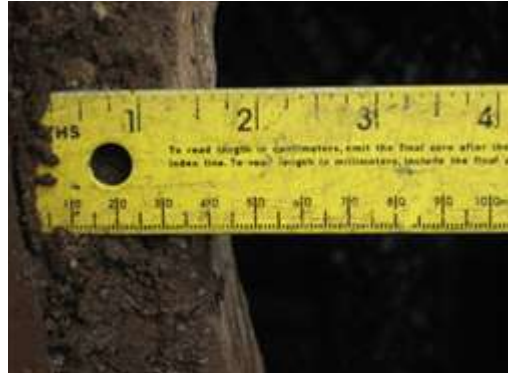
Defect 3

Offset: **2** (in.)

Frame offset

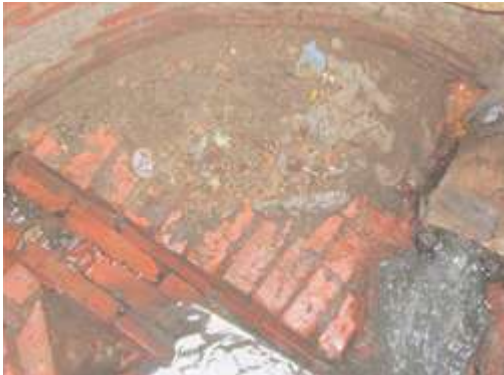
Defect 2

Condition: ☐ Sound ☐ Cracked ☐ Root Intrusion ☐ Deteriorated ☐ Leaks ☒ **Debris**

Debris on bench

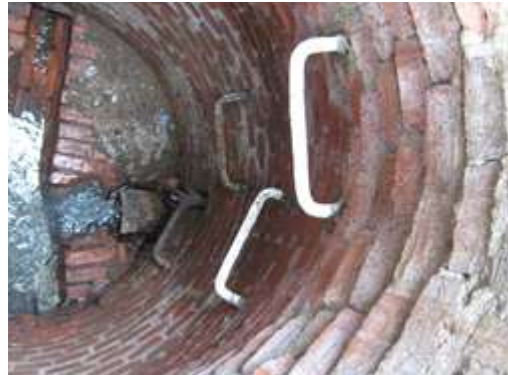
Defect 1

☒ **Corroded**

Corroded steps

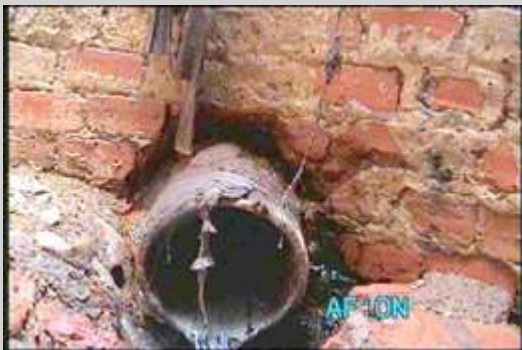
10 O'Clock Inflow

Infiltration: **Evidence** Pipe Seal Cond: **Broken**
